MADISON RIVER, MONTANA
REPORT ON
*FLOOD EMERGENCY
MADISON RIVER SLIDE*

*VOLUME I
MAIN REPORT*

U. S. ARMY ENGINEER DISTRICT, OMAHA
CORPS OF ENGINEERS
OMAHA, NEBRASKA
SEPTEMBER 1960

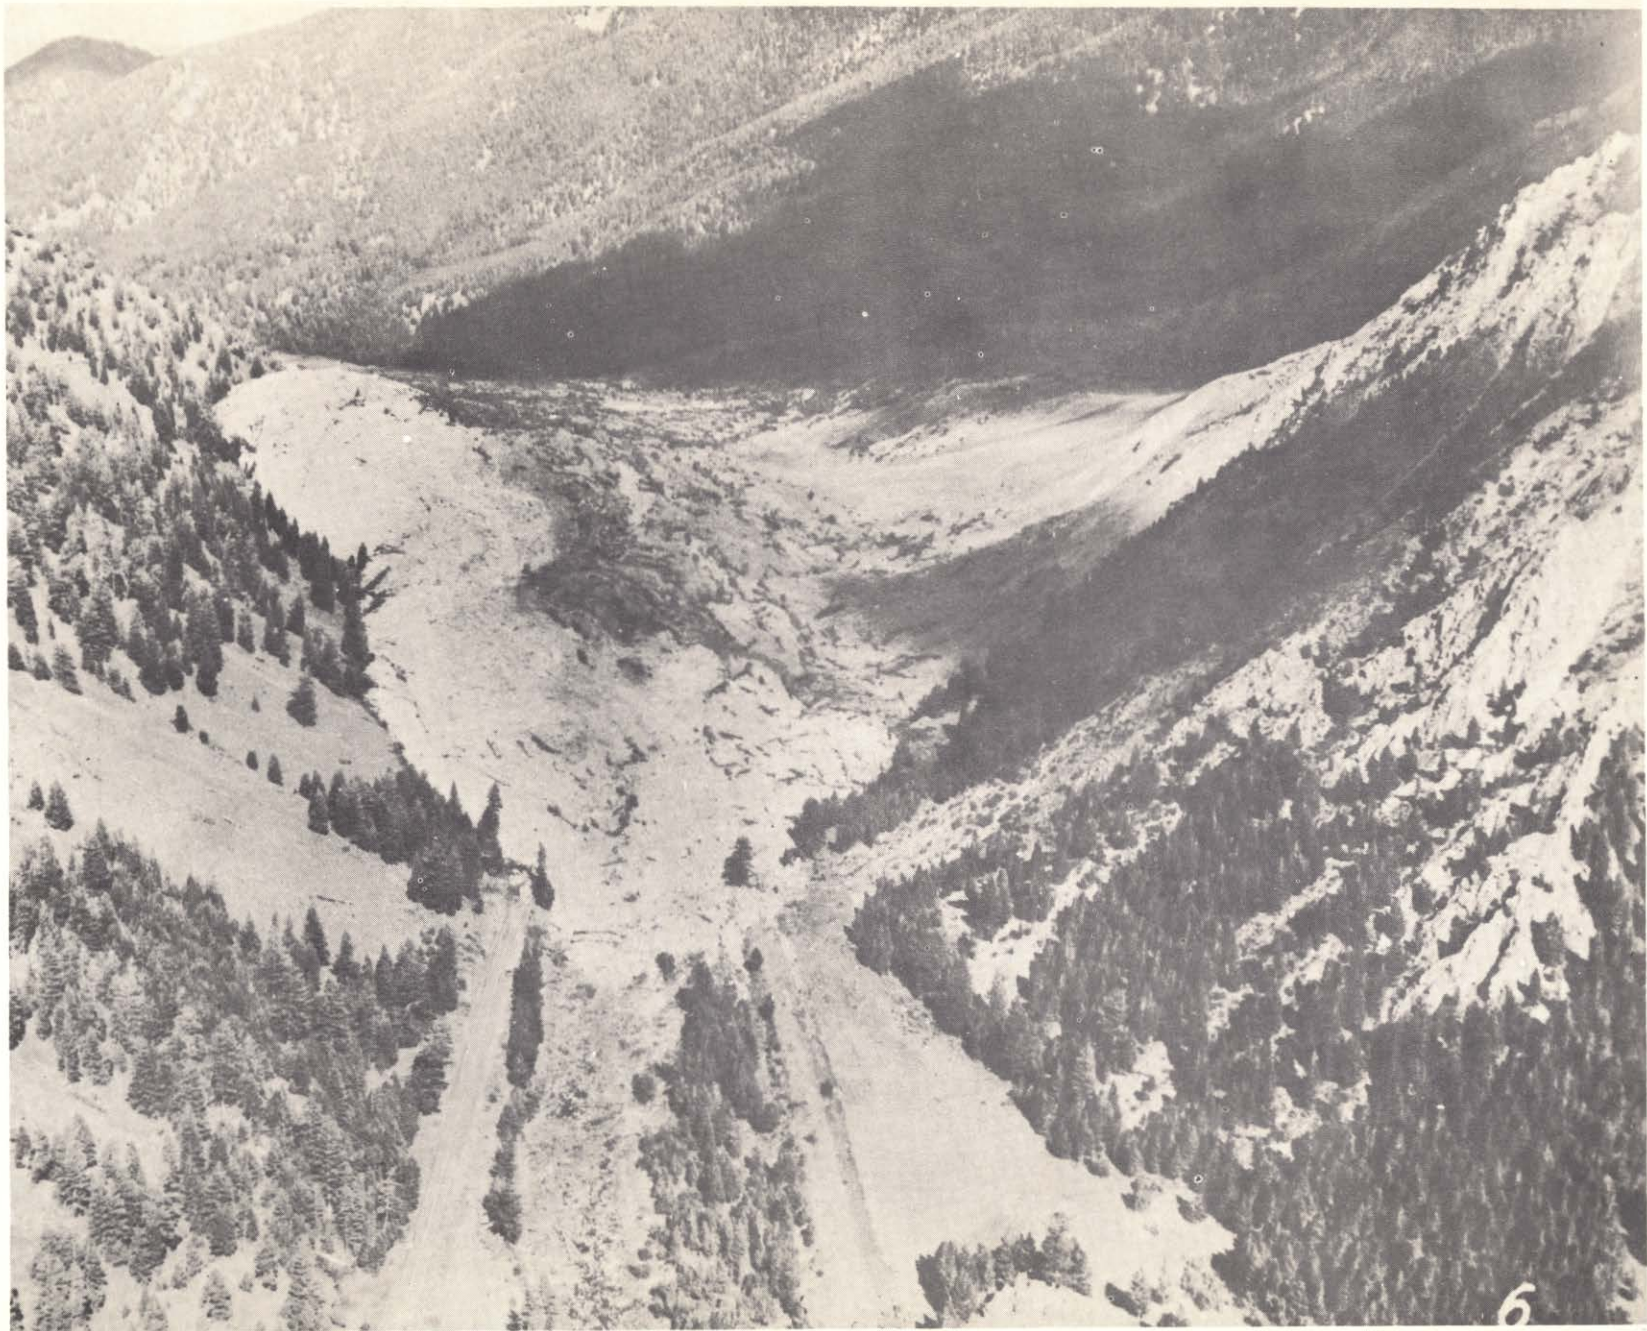
6
Photo 1. About 20 August 1959. Aerial view of Madison River slide about 2 days following earthquake. USDA - Forest Service photo.

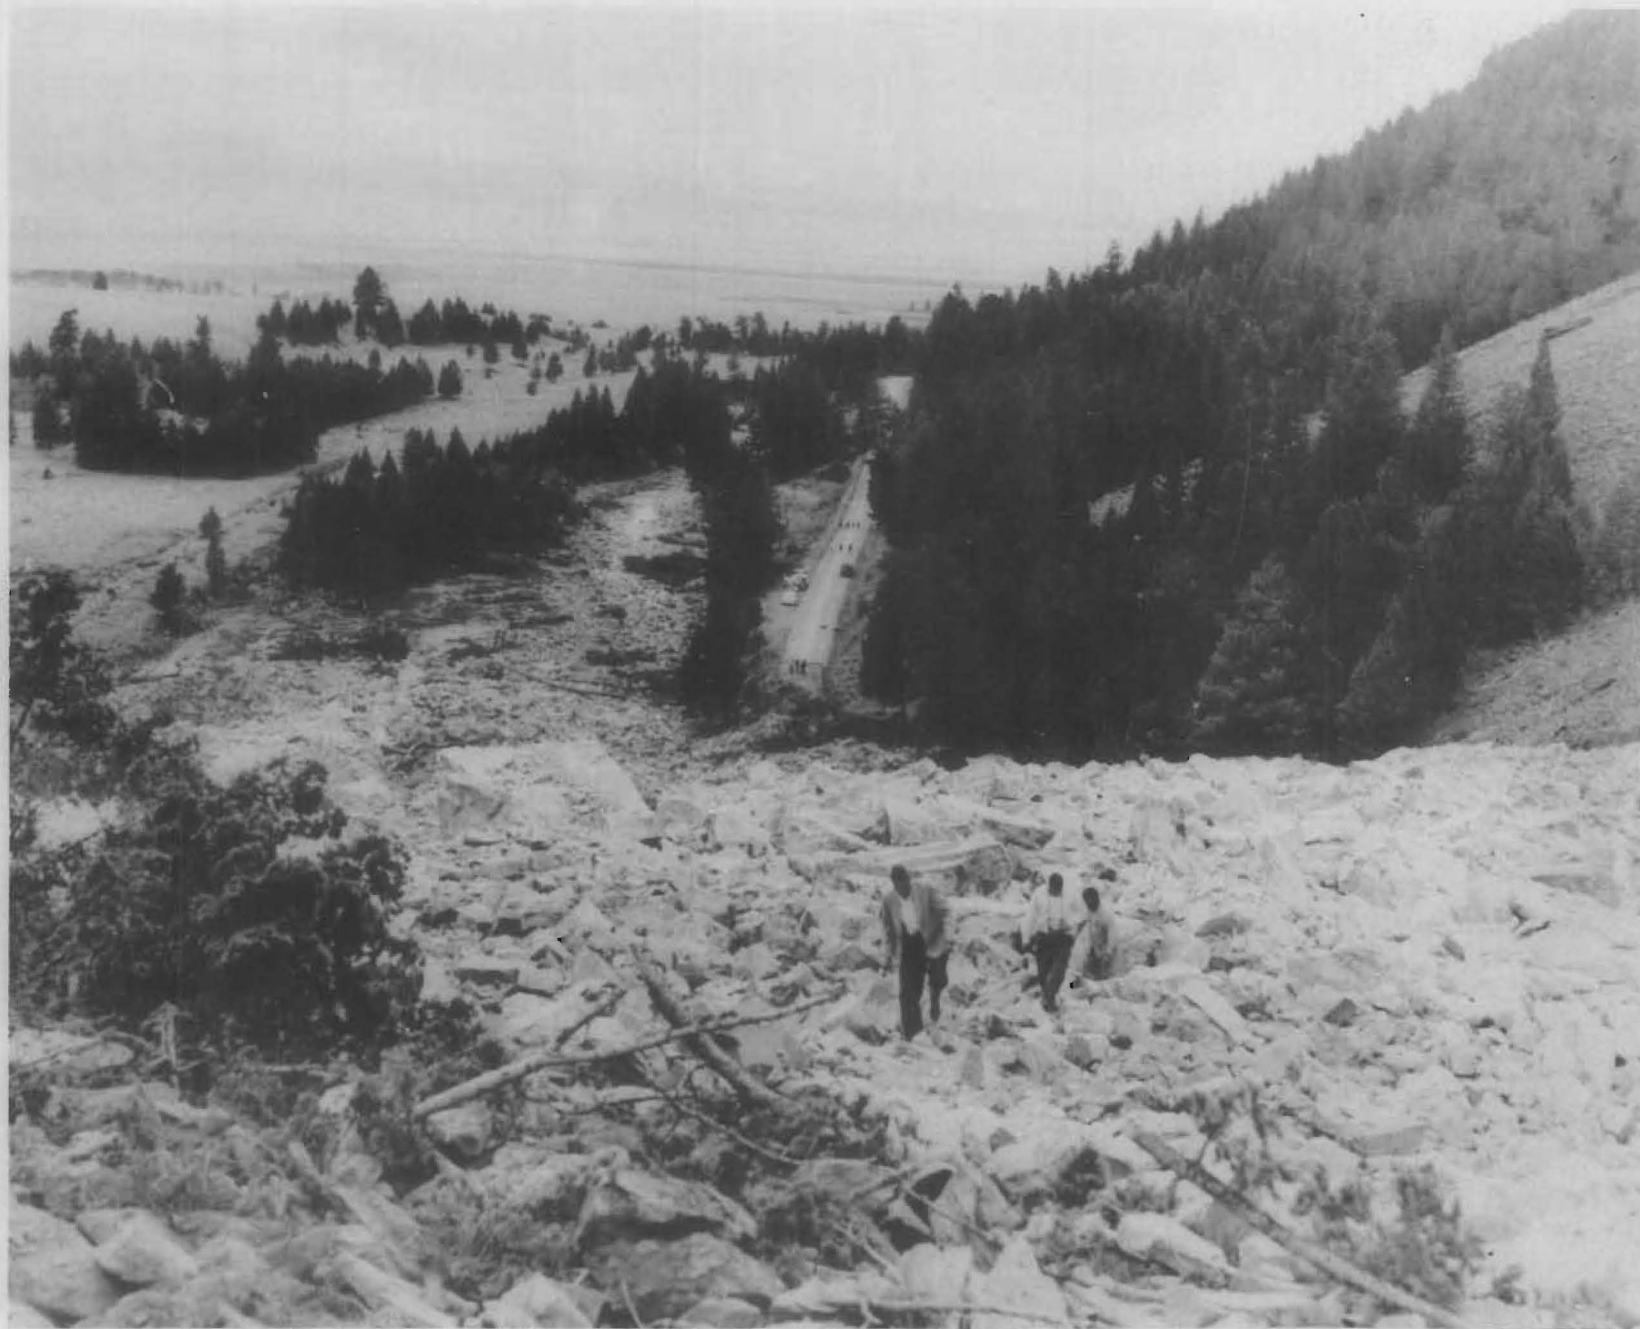
Photo 2. About 21 August 1959. A Forest Service photo, looking downstream at large rocks on downstream slope of slide and at the streambed below slide. (For later view, see Photo 27).

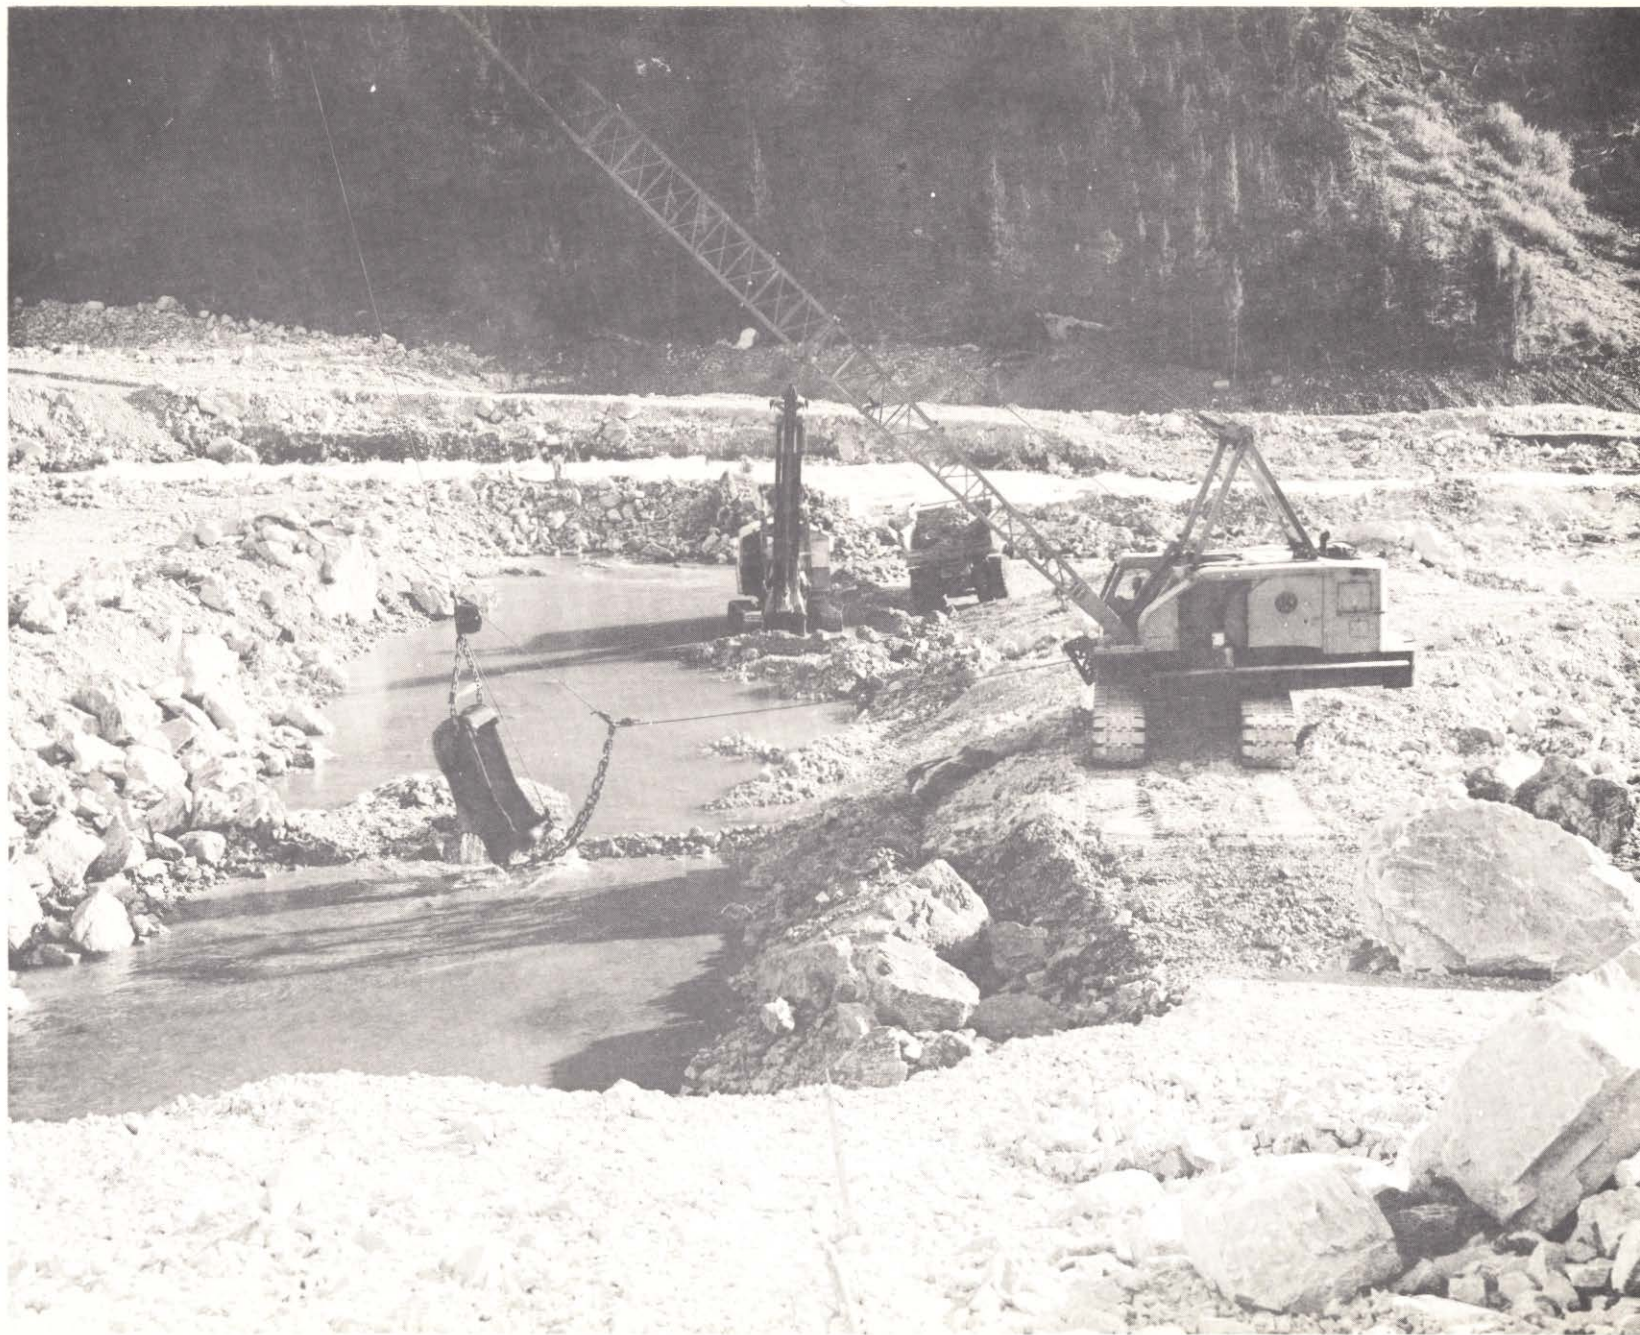
Photo 13. 16 September 1959. Foundation excavation for first rock filled drop structure at about Station 6+00.

49. Serious consideration was given at this time to obtaining durable rock from suitable quarry sites in the mountains nearby, in quantities sufficient to construct two or three permanent rock drop structures, with rock stilling basins, to stop the continued erosion of the spillway, which several times threatened to get out of control. Obviously, such a plan would be both time-consuming and costly, and it was discarded in favor of a plan to lower the spillway and reduce the storage in Earthquake Lake. Foundation excavation for part of the first drop structure is shown in Photo 13.

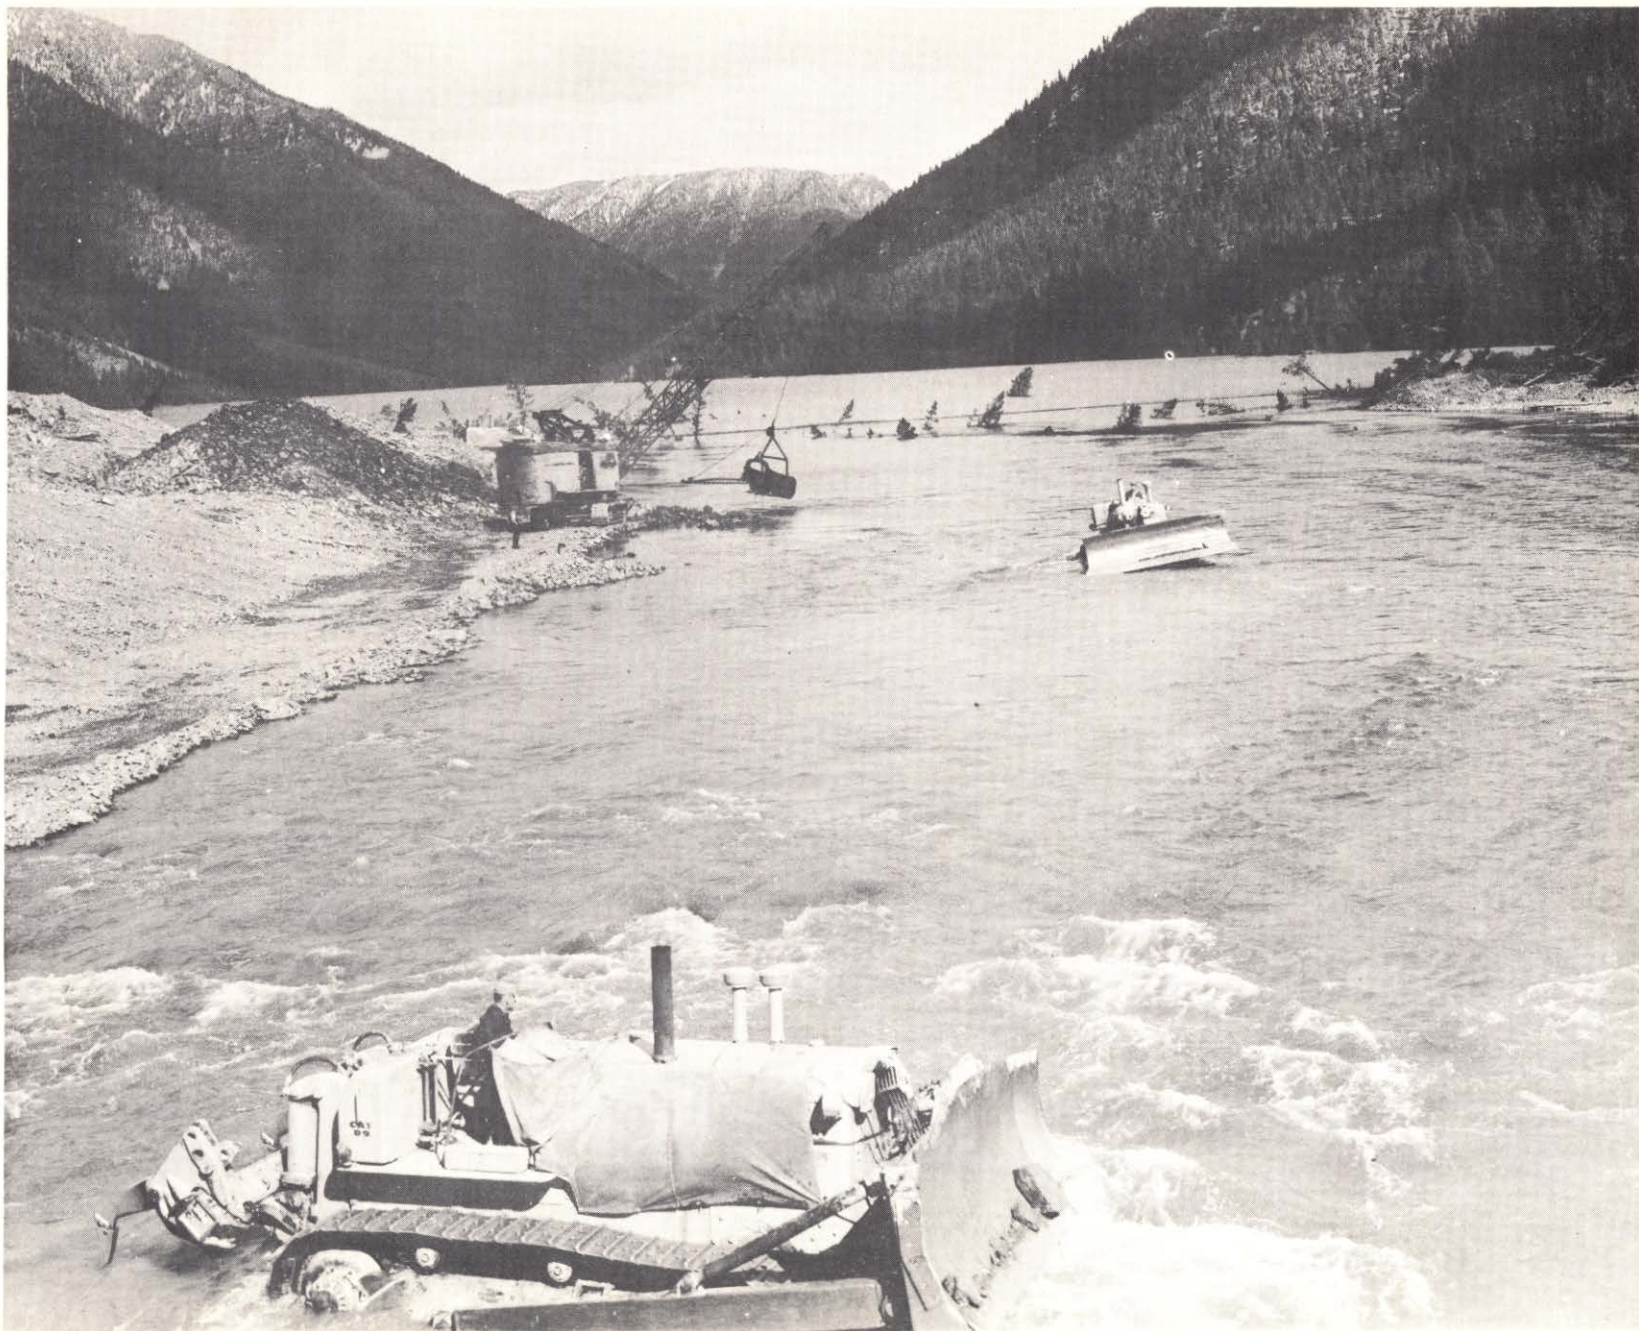
Photo 15. 29 September 1959. Starting to lower the spillway channel near the outlet of Earthquake Lake.

54. Lowering the Spillway. Computations showed that, if the spillway crest could be lowered by about 50 feet, the volume of water remaining in storage would not be sufficient to cause a really disastrous flood downstream, even with rapid failure of the remaining slide dam. The third and final phase of construction was started on 25 September, when tractors with dozers and rippers were put to work loosening the material on the crest, to see if it would be carried downstream by the flowing water. It was found that the velocity of flow was not high enough to move any but the very fine material and that other means would have to be found to move any substantial quantities of rock.

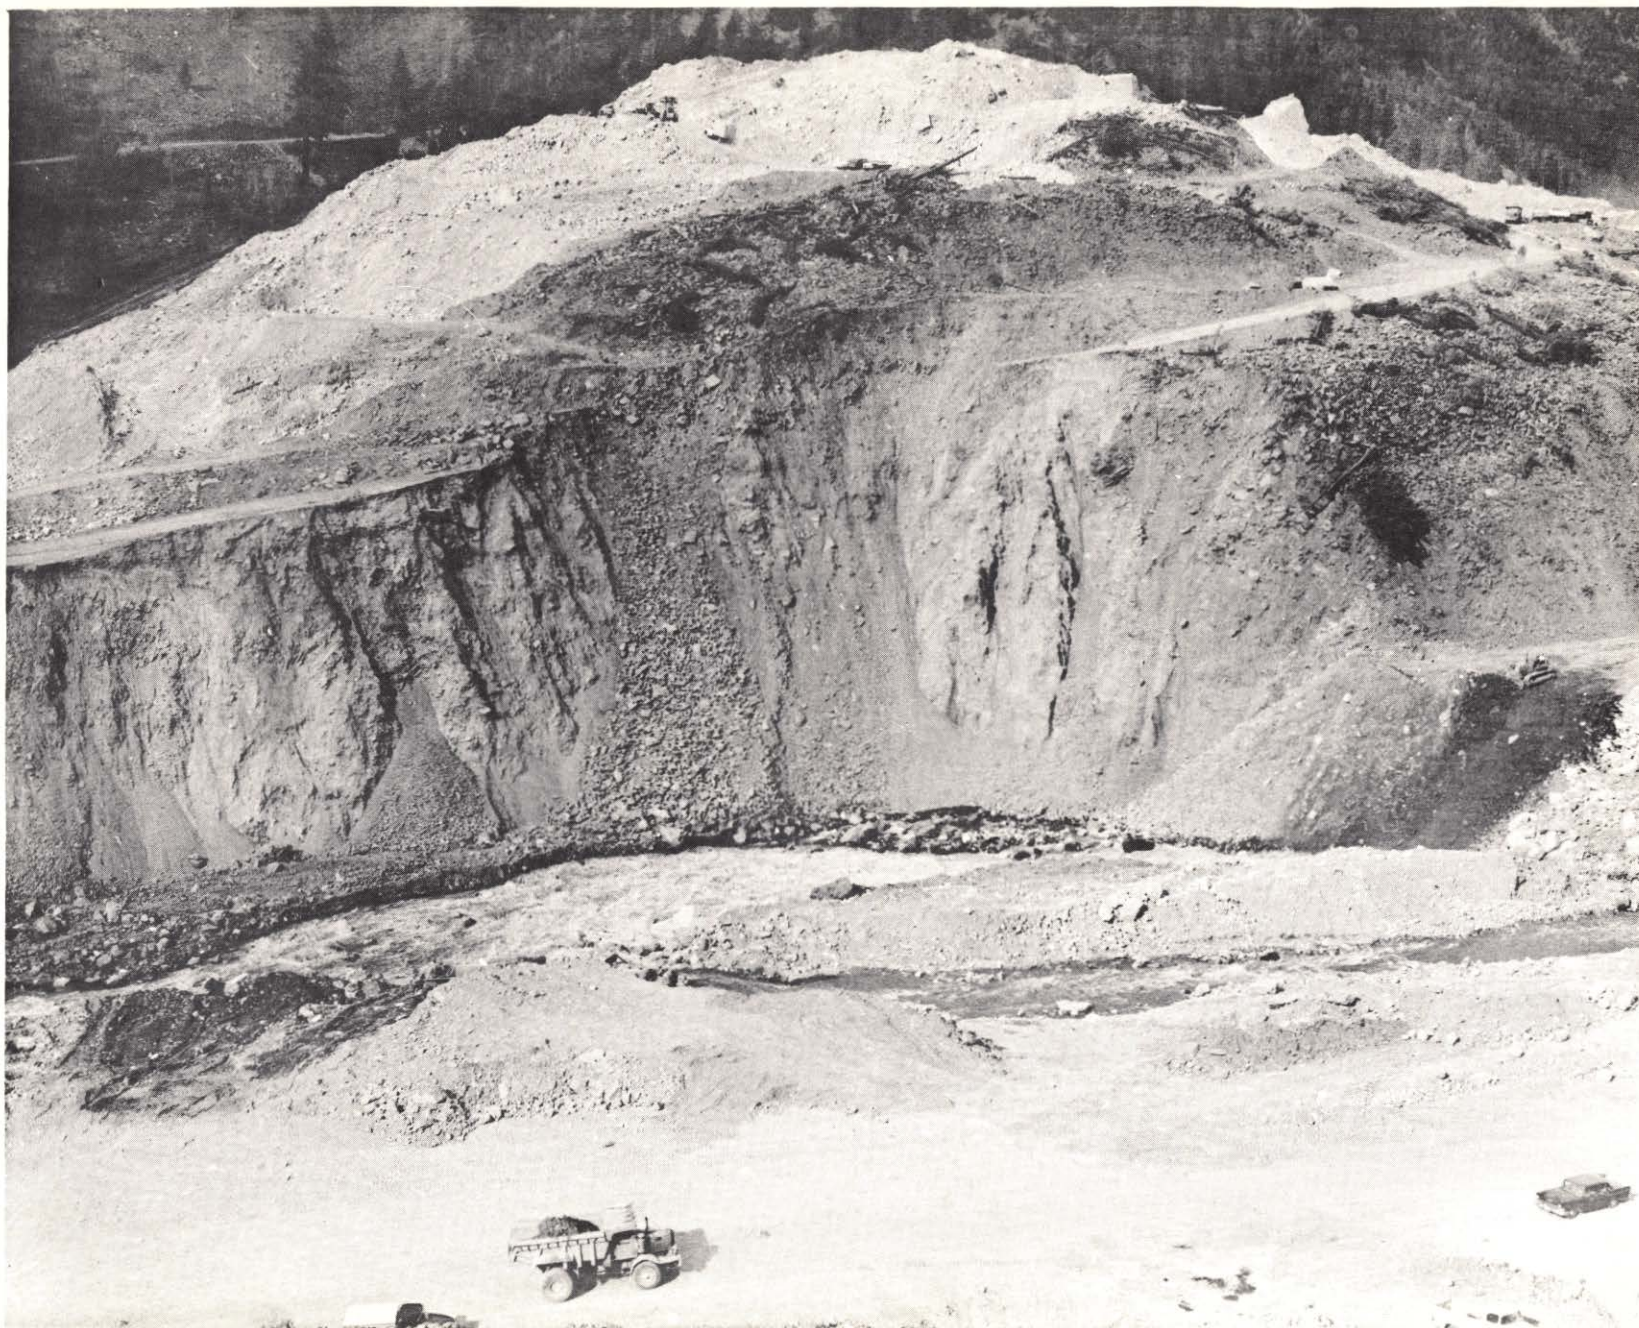
Photo 17. 5 October 1959. Rapid erosion of right bank between Stations 11+00 and 15+00.

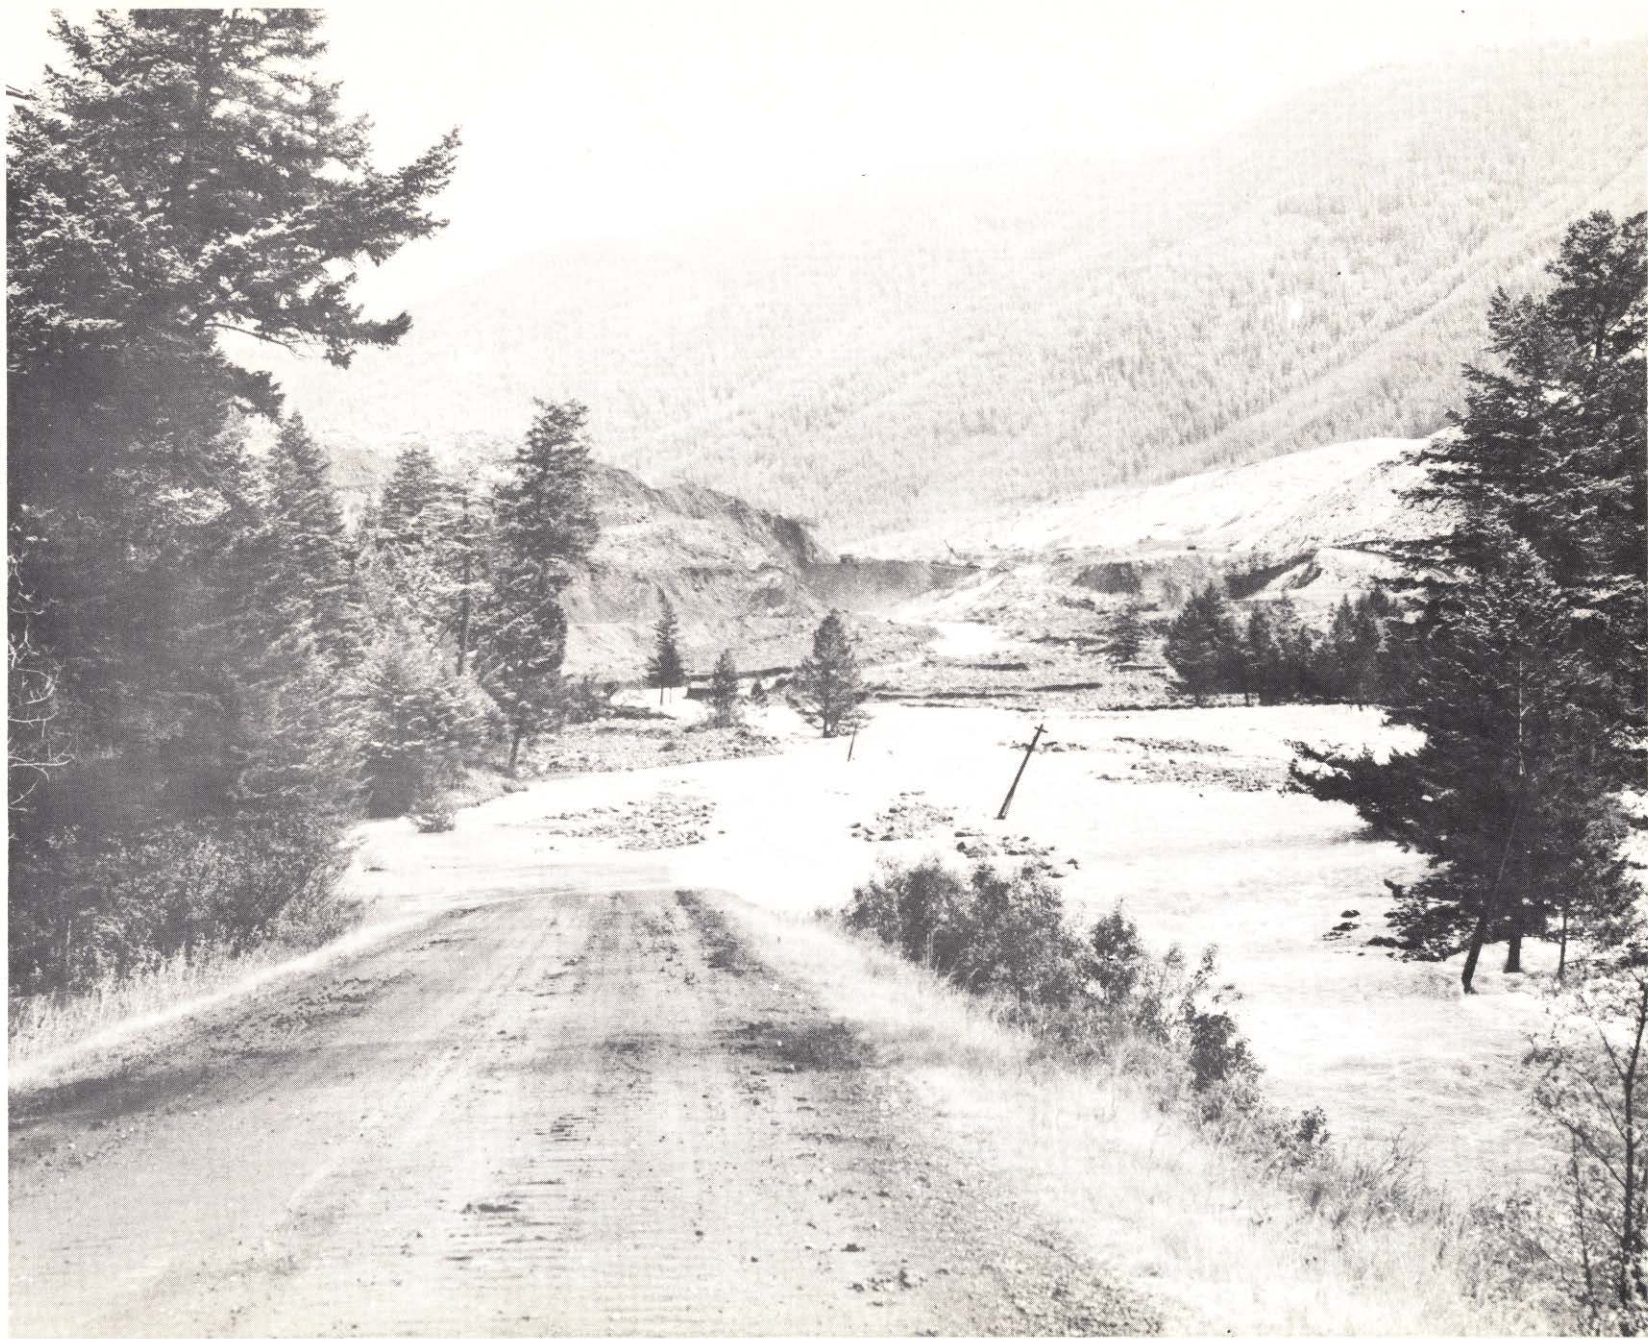
Photo 18. 7 October 1959. First in a ~~series~~ of three photographs showing rapid development of the fan below the slide.

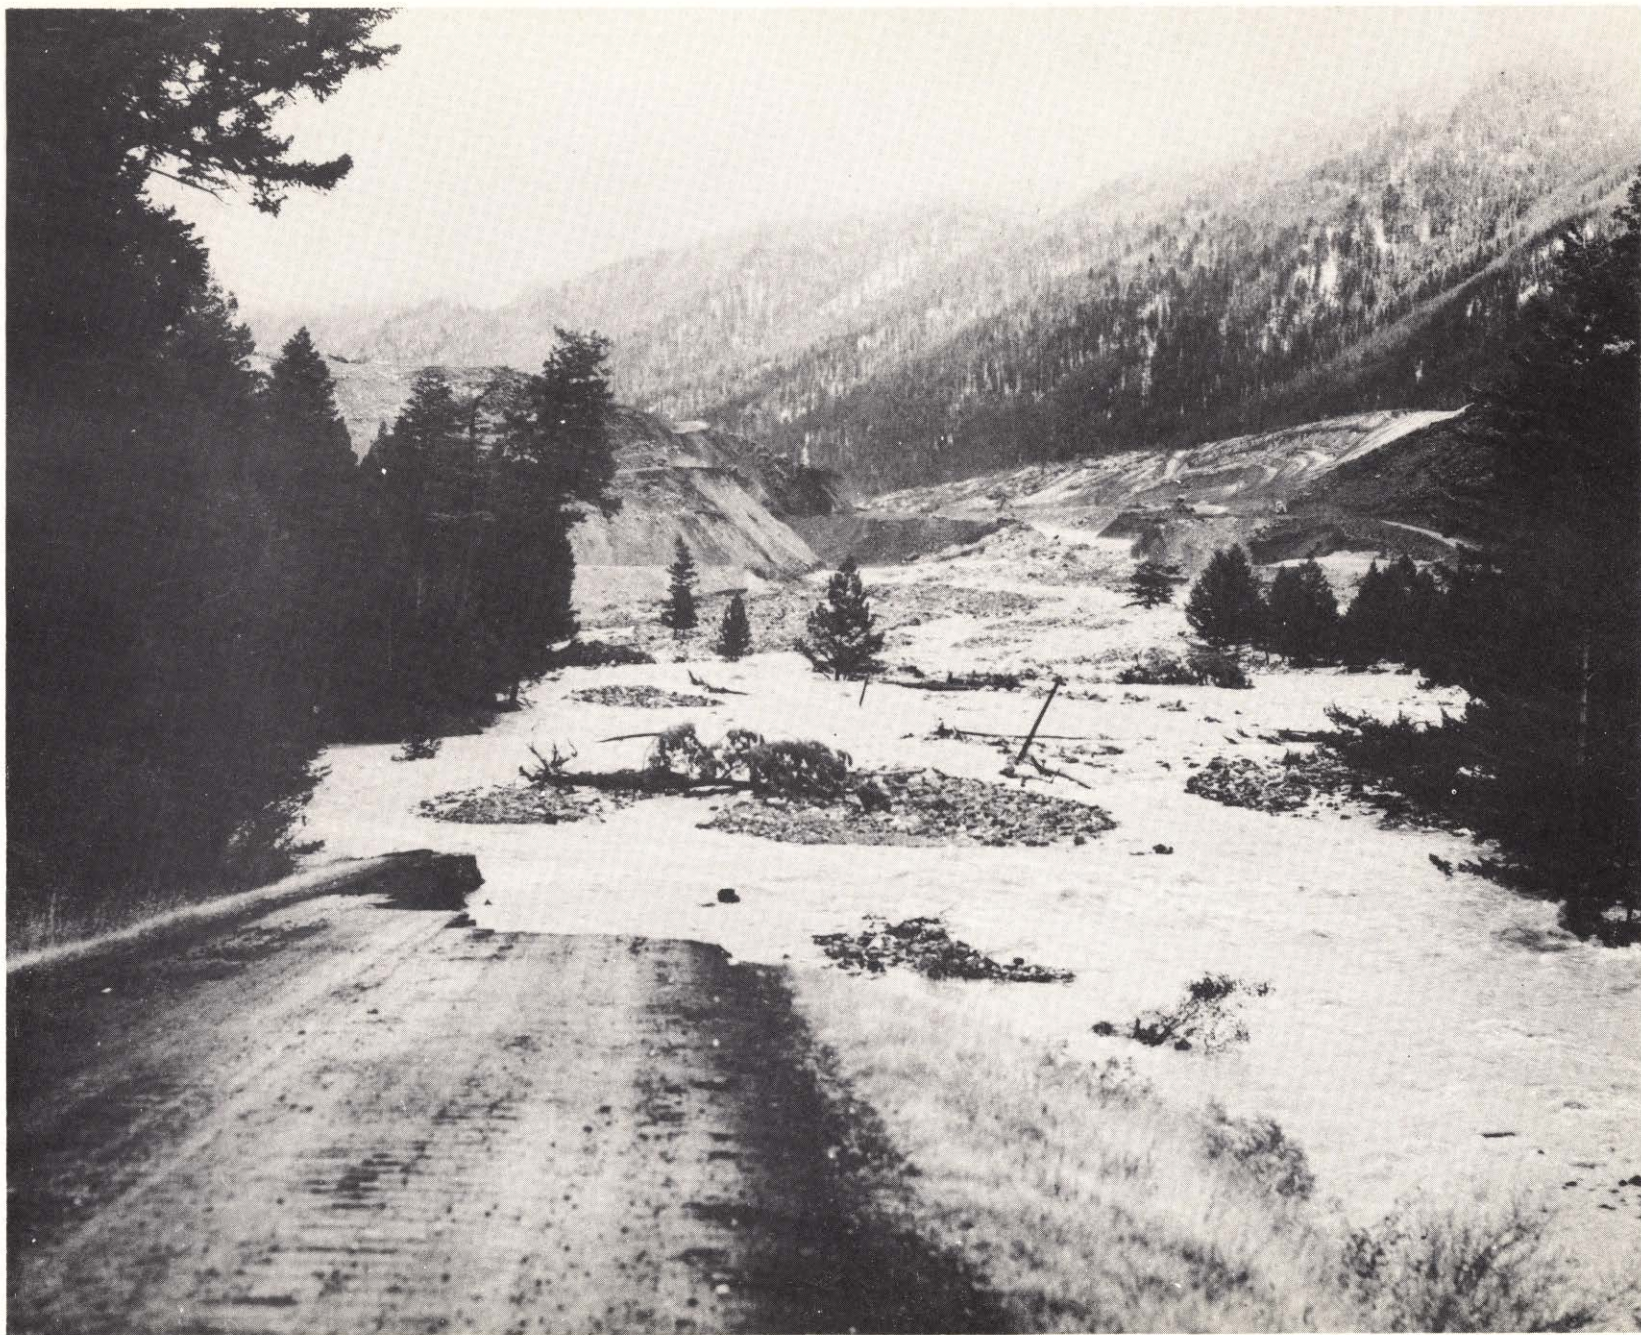
Photo 19. 9 October 1959. View showing rapid development of fan and damage to access road.

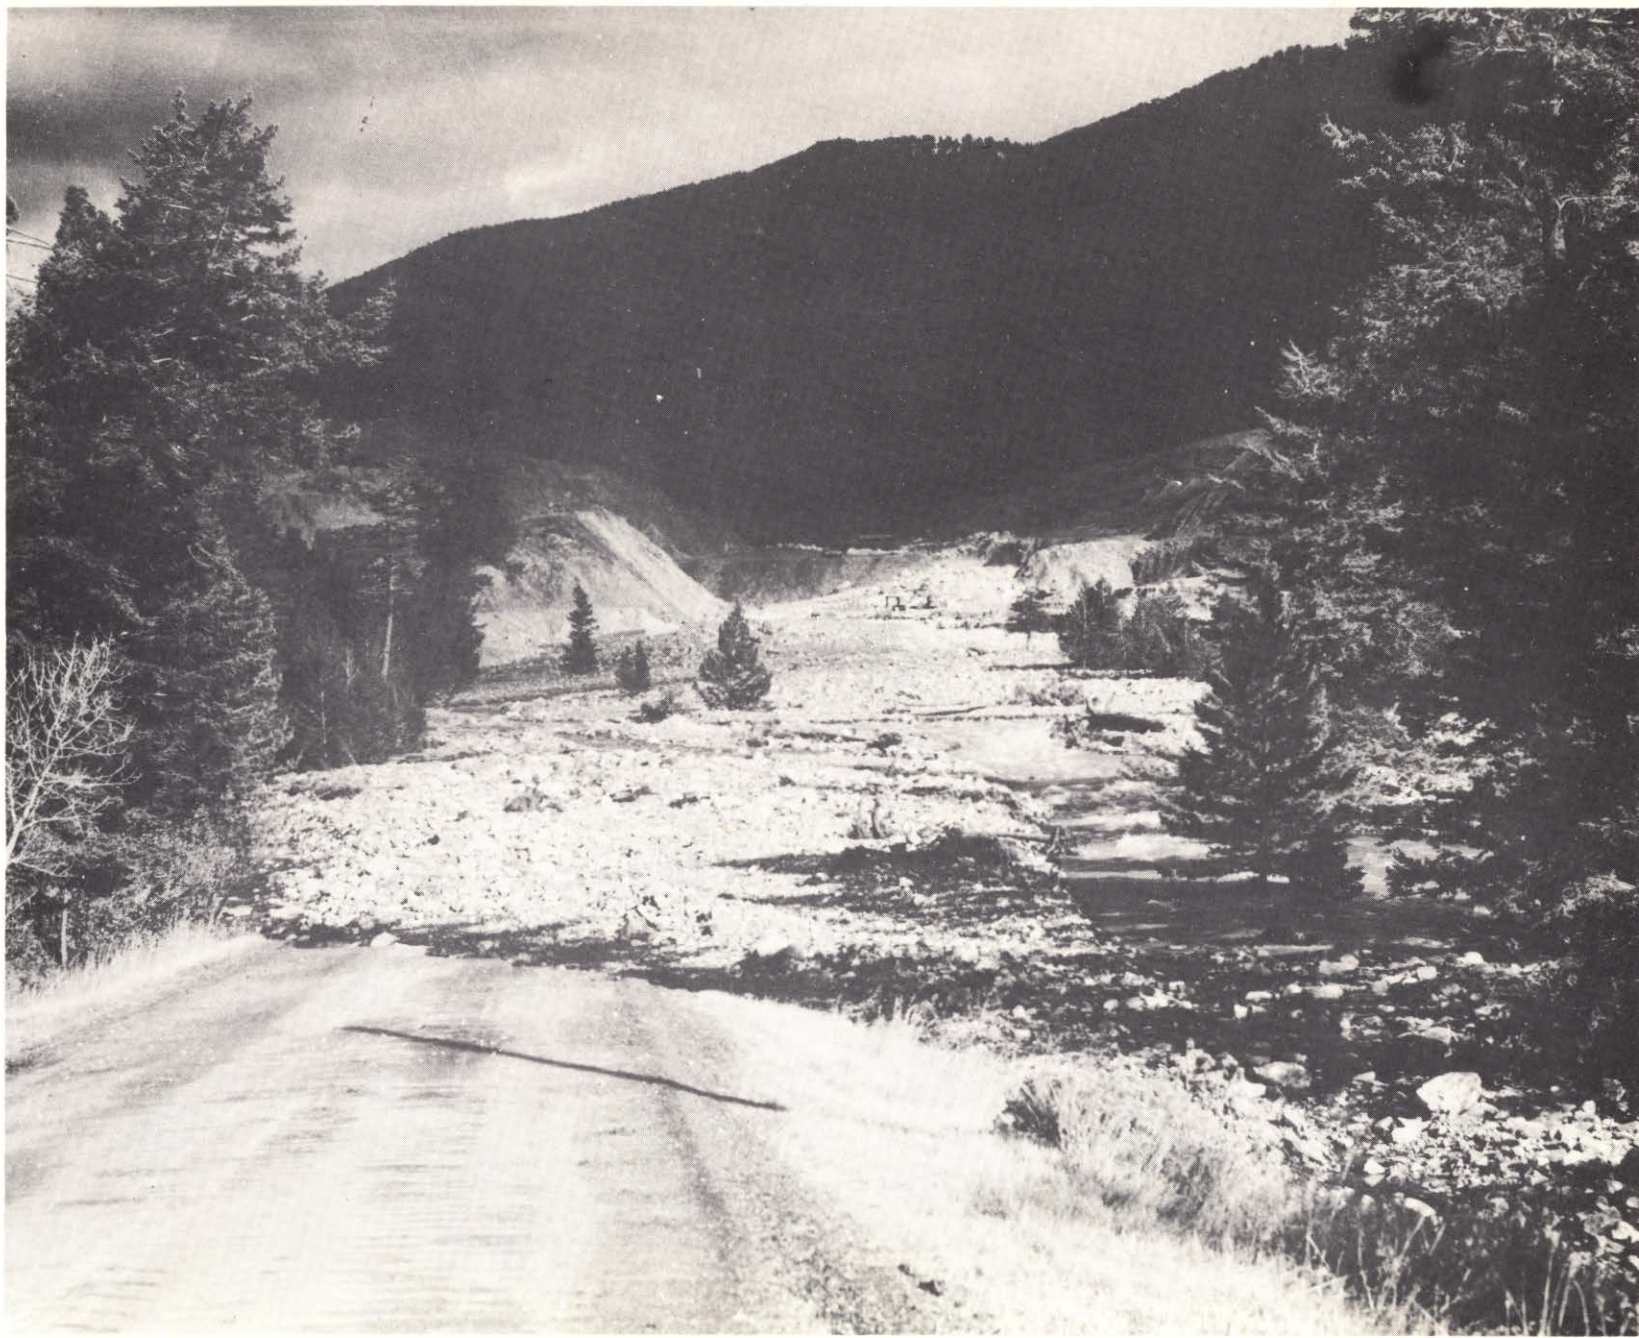
Photo 20. 11 October 1959. View showing rapid development of fan.

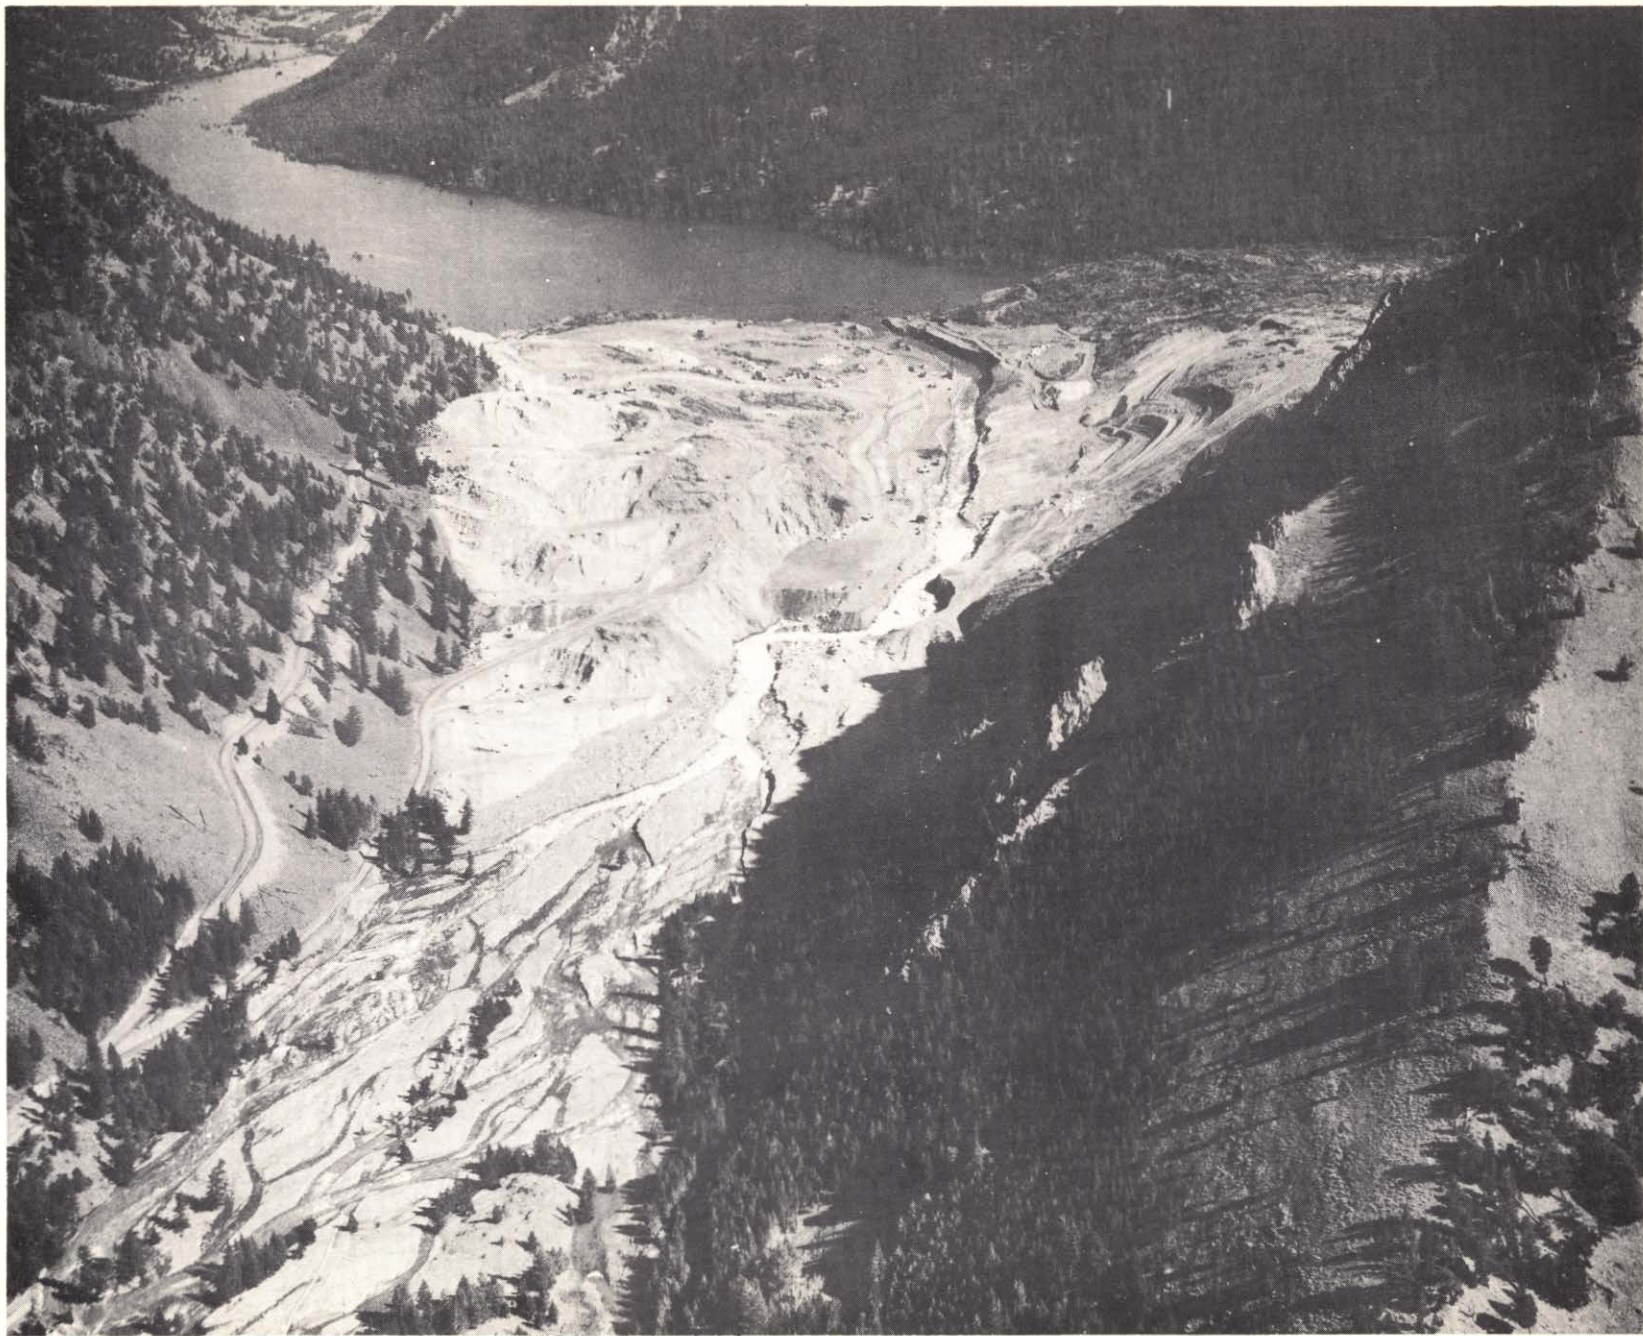
Photo 24. 17 October 1959. Aerial view of slide looking downstream showing spillway channel and buildup of fan below the slide.

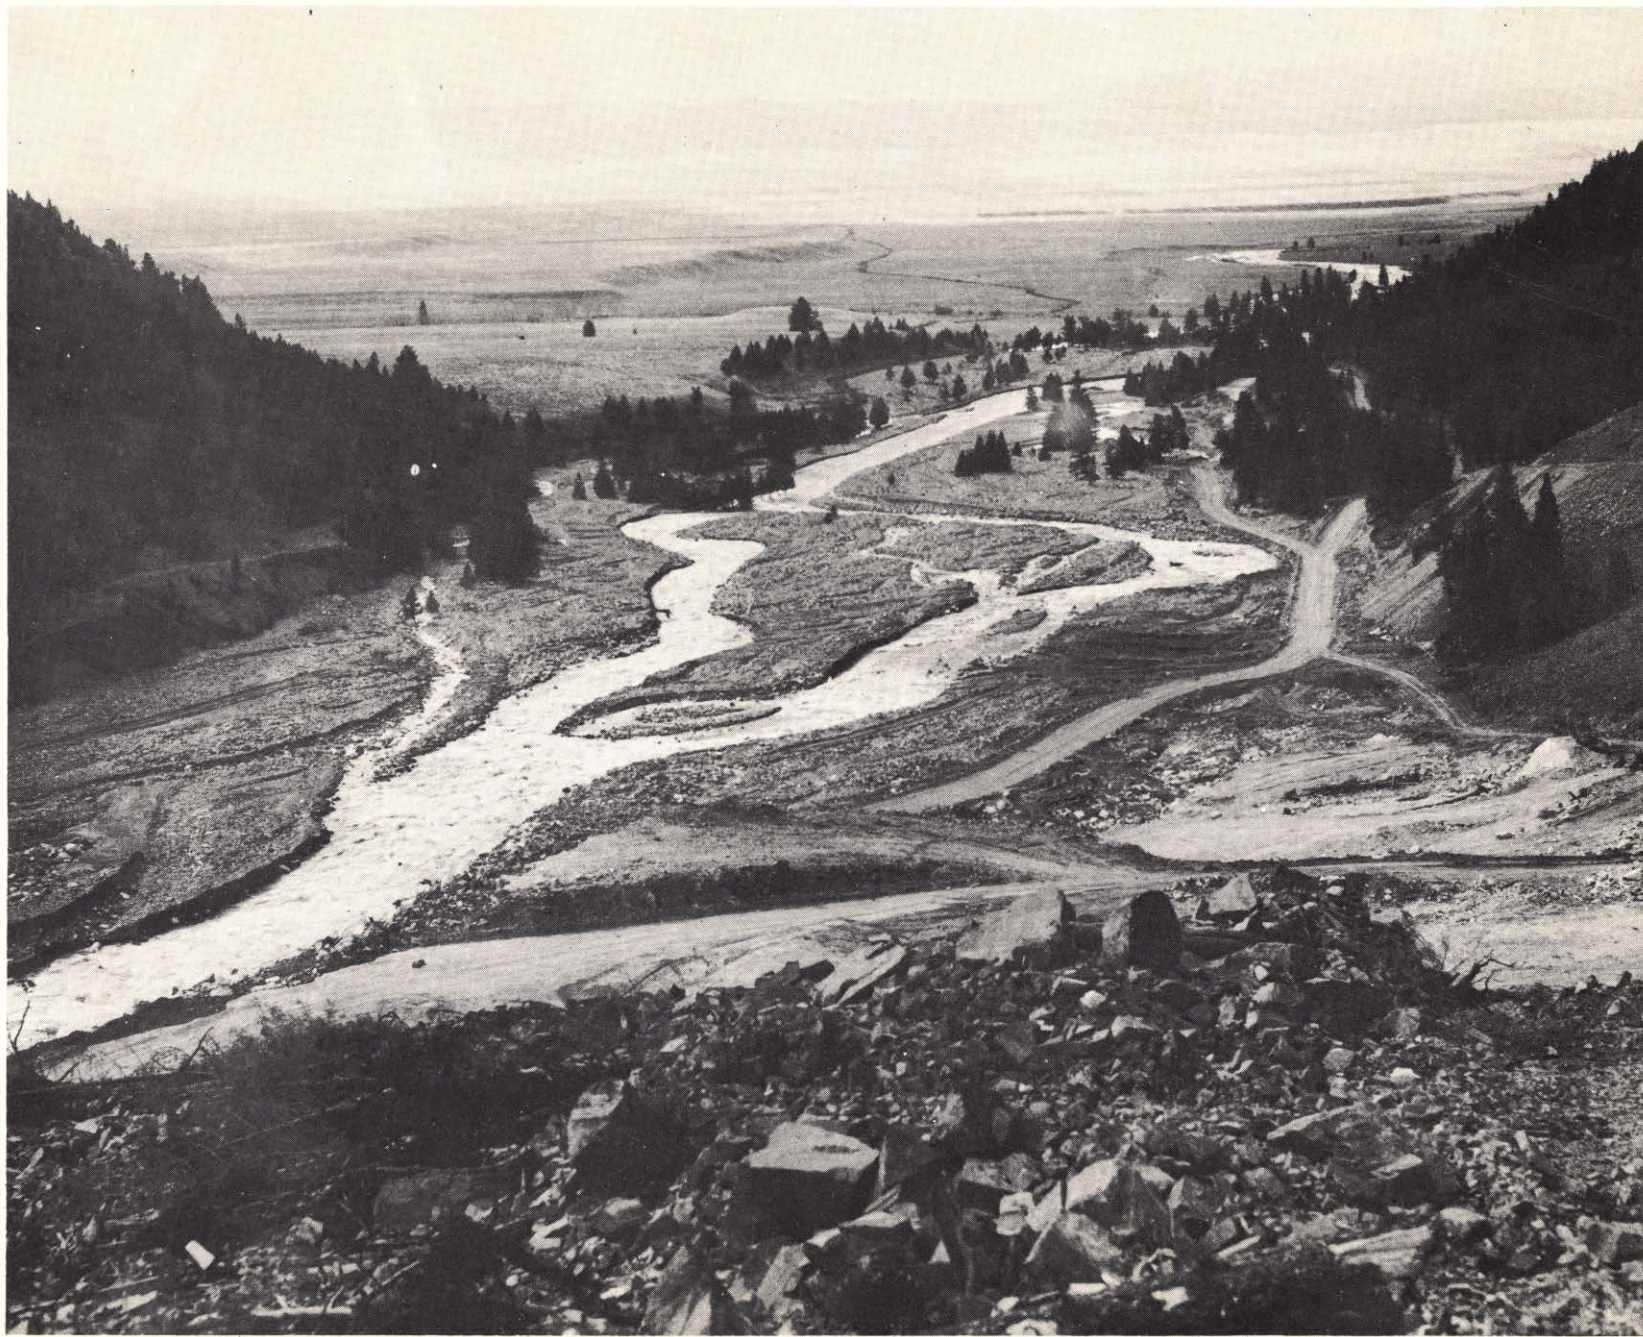
Photo 27. 28 October 1959. View of fan at lower end of slide at end of construction period (for earlier view, see Photo 2).
